THIS SURVEY WAS PERFORMED AT THE REQUEST OF GARY JEPSON, OWNER OF THE LAND DESCRIBED IN DEED INSTRUMENT NO. 20111280, DEED RECORDS OF GRANT COUNTY, OREGON. THE PURPOSE OF THIS SURVEY WAS TO MONUMENT CERTAIN CORNERS OF MR. JEPSON'S PROPERTY AND TO MARK WITH STEEL POSTS AND FLAGGING THE WEST PROPERTY LINE. THIS REQUIRED A DEPENDENT RESURVEY OF SECTION 17.

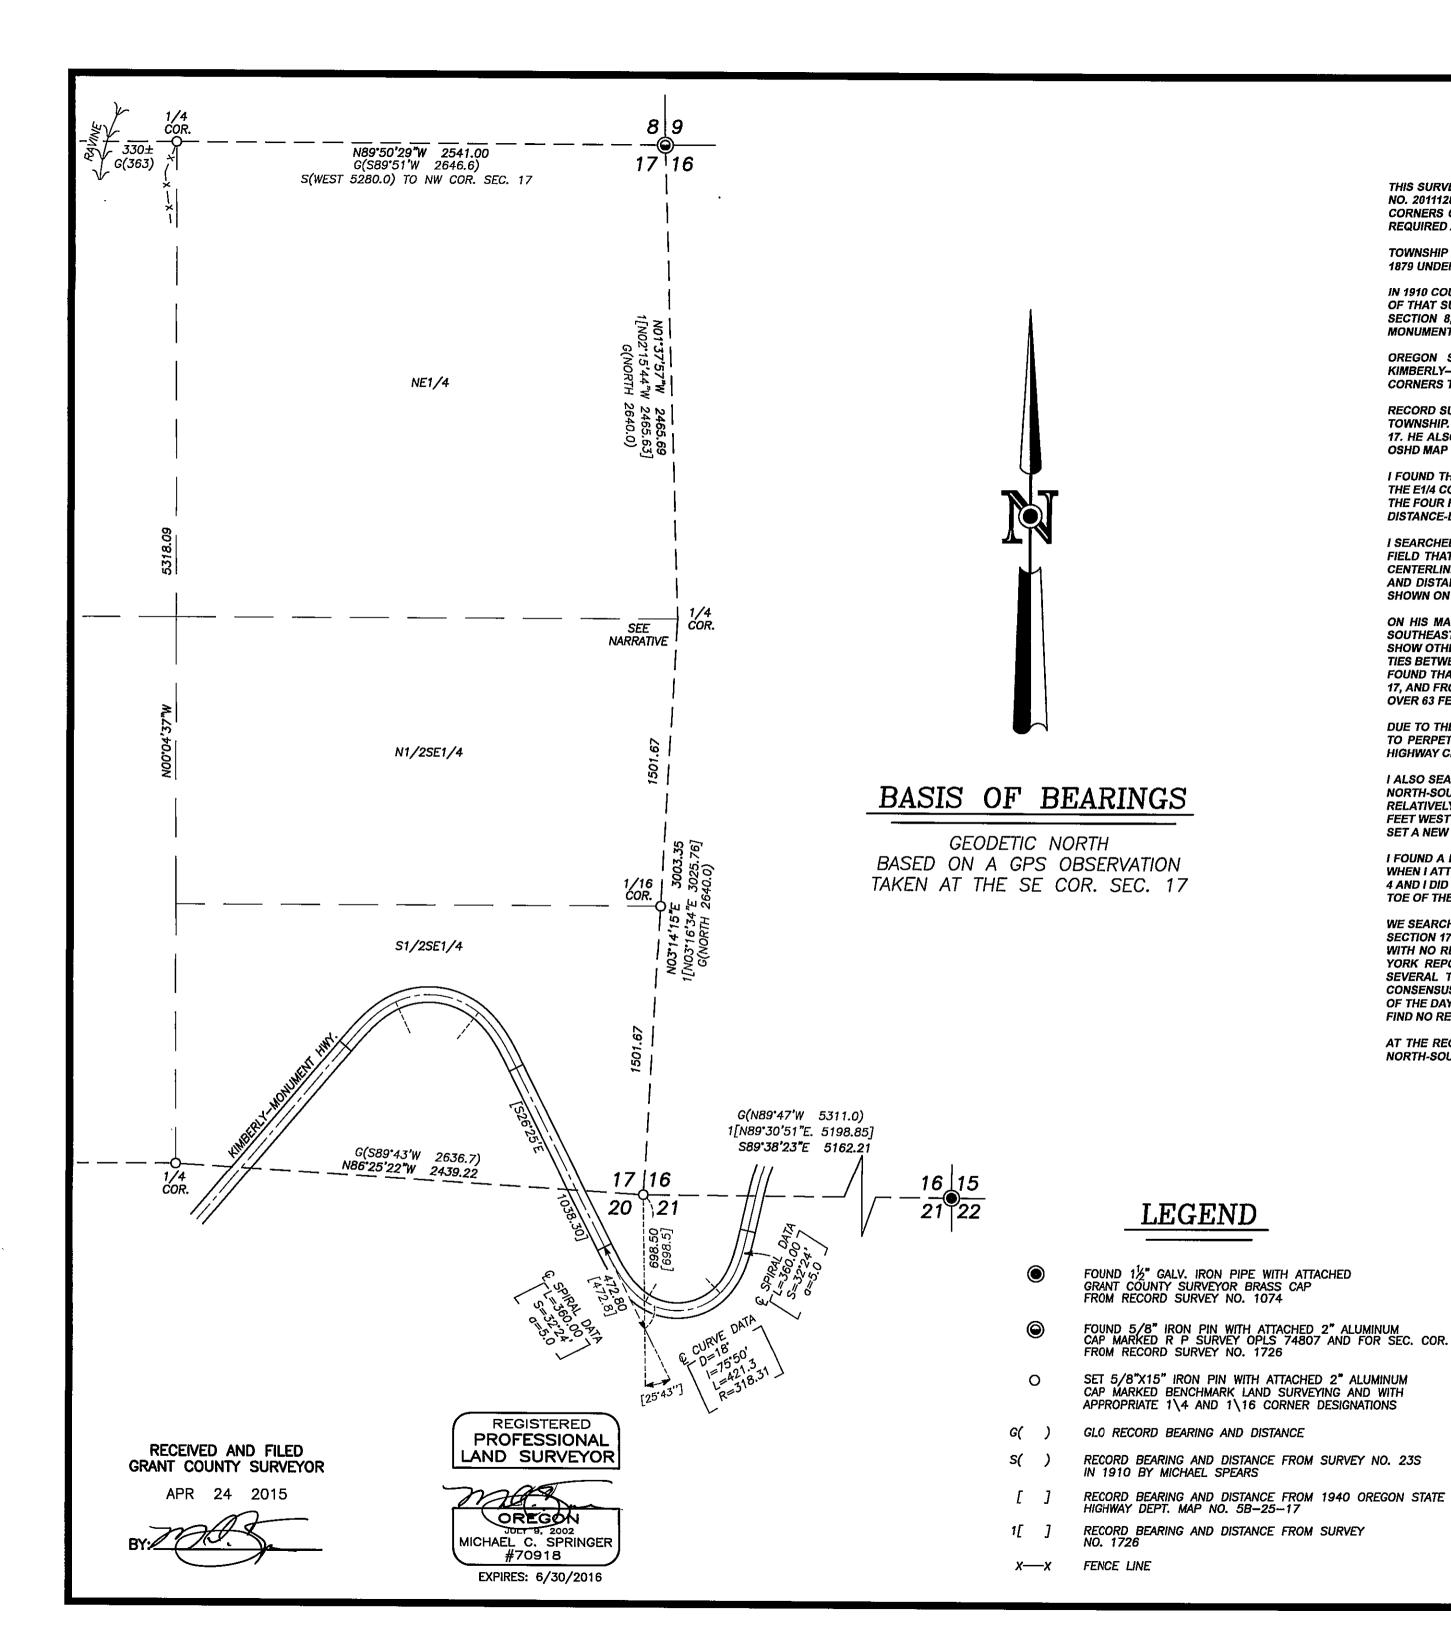
I FOUND THE MONUMENT SET BY RANDELL AT THE NORTHEAST CORNER OF SECTION 17 IN GOOD CONDITION, HOWEVER, AT THE E1/4 CORNER I DID NOT FIND RANDELL'S MONUMENT. I DID FIND A PILE OF STONE AT THE CORNER LOCATION AND TWO OF THE FOUR REFERENCE POINTS HE REPORTEDLY SET. I CALCULATED THE POSITION OF THE E1/4, AS SHOWN HEREON, USING A DISTANCE-DISTANCE INTERSECTION FROM THE TWO FOUND REFERENCE POINTS.

I ALSO SEARCHED FOR, BUT DID NOT FIND THE ORIGINAL MARKED STONE AT THE N1/4 CORNER OF SECTION 17. I DID FIND A NORTH-SOUTH FENCE THAT TERMINATED AT THE TOP OF A 10 FT. TALL VERTICAL BLUFF. THE END OF THE FENCE FITS RELATIVELY WELL WITH THE NORTHEAST CORNER OF THE SECTION AND ALSO WITH THE GLO CALL TO A DEEP RAVINE 363 FEET WEST OF THE CORNER. I ACCEPT THE END OF THE FENCE AS THE BEST AVAILABLE EVIDENCE OF THE N1/4 CORNER AND SET A NEW MONUMENT.

I FOUND A PORTION OF THE MARKED STONE AT THE S1/4 CORNER OF SECTION 17. THE STONE WAS PARTIALLY BURIED AND WHEN I ATTEMPTED TO REMOVE IT, IT BROKE INTO SEVERAL SMALLER PIECES. THE PIECE I RECOVERED WAS MARKED WITH A 4 AND I DID NOT FIND REMAINS OF THE REST OF THE STONE. THE POSITION OF THIS STONE FITS WELL WITH GLO CALLS TO THE TOE OF THE HILL AND RIVER.

AT THE REQUEST OF MR. JEPSON, I POSTED THE LINE FROM THE S1/4 CORNER NORTHERLY ABOUT 1,400 FEET ALONG THE NORTH-SOUTH CENTER OF SECTION LINE OF SAID SECTION 17.
